Metallurgical Engineering Services

REPORT OF: Fastener Analyses

IDENTIFICATION: 1 ea. Lot of OWT Bolts: P/N: 56650

1 ea. Lot of 4" Screws: P/N: 56627

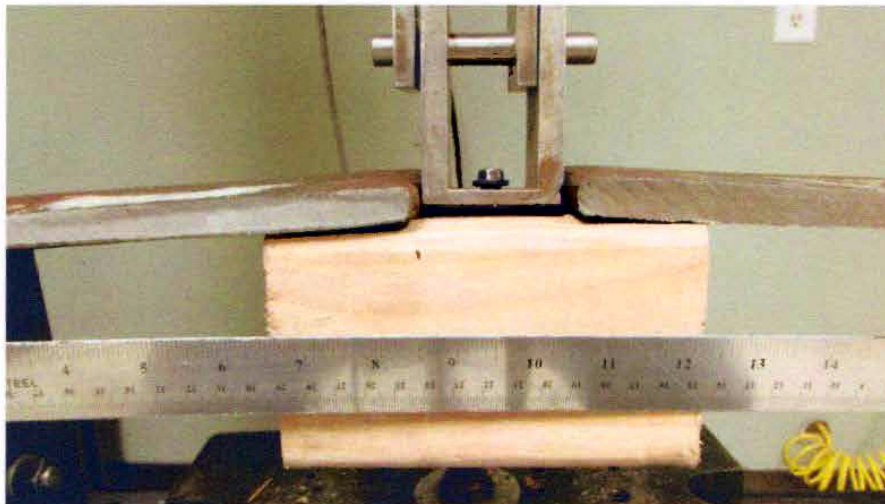
Figure 1: Screw withdrawal test setup

Screw withdrawal testing per ASTM D1037 was performed using a 4" x 4" wood sample. In all cases, the screw withdrew from the wood with no splitting.

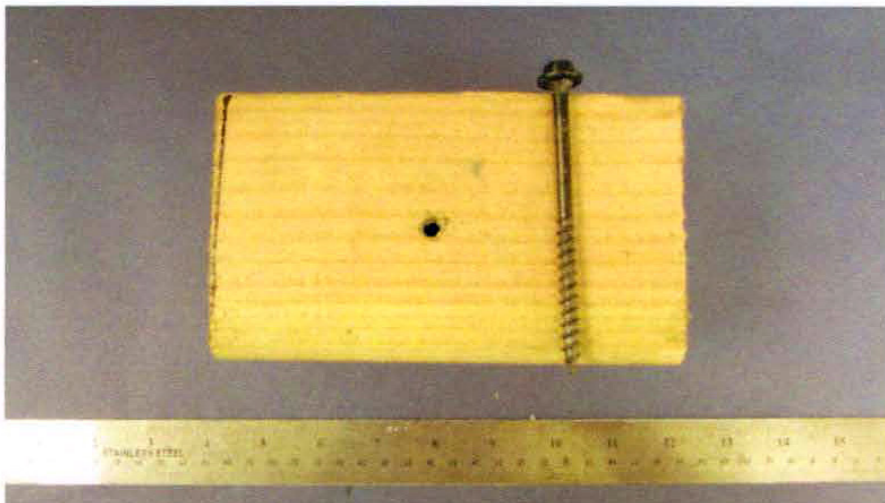
Figure 2: Screw withdrawal failure mechanism

Sample ID	Peak Load, lbs	Observations
56627-1	2,136	Screw pulled through/out with no splitting in wood
56627-2	1,777	
56627-3	2,125

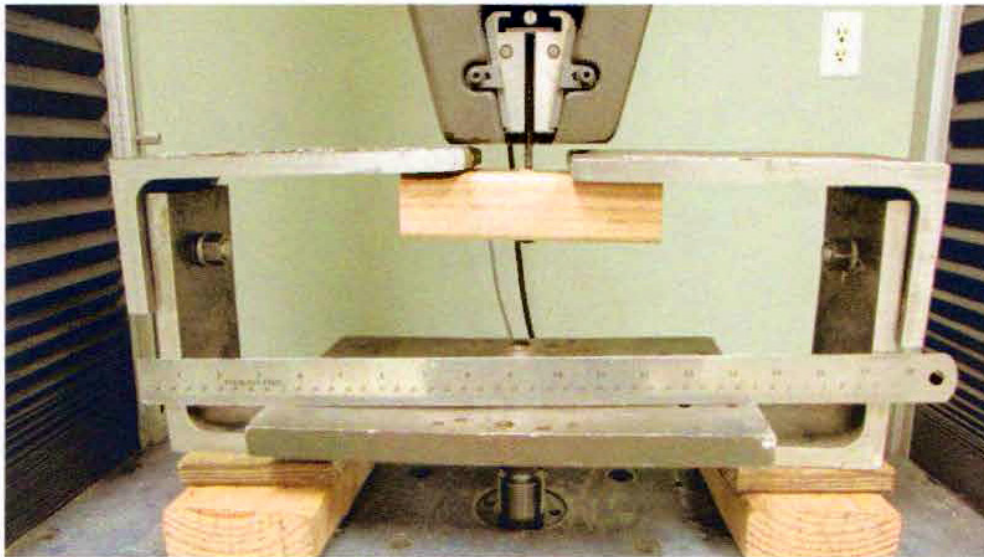
Figure 3: Screw pull through test setup

Screw pull through testing per ASTM D1037 was performed using a 2 x 4 wood sample. In all cases the screw pulled through the wood materials.

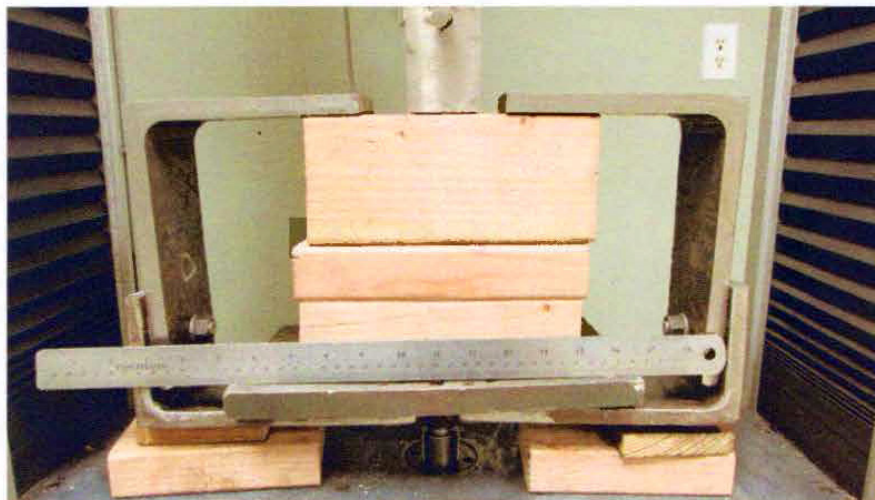
Figure 4: Bolt withdrawal test setup for OWT

Bolt withdrawal testing was performed on the OWT per ASTM D1037 with a 2 x 4 and 4 x 4 wood samples. In all cases, failure occurred in the hex nut.

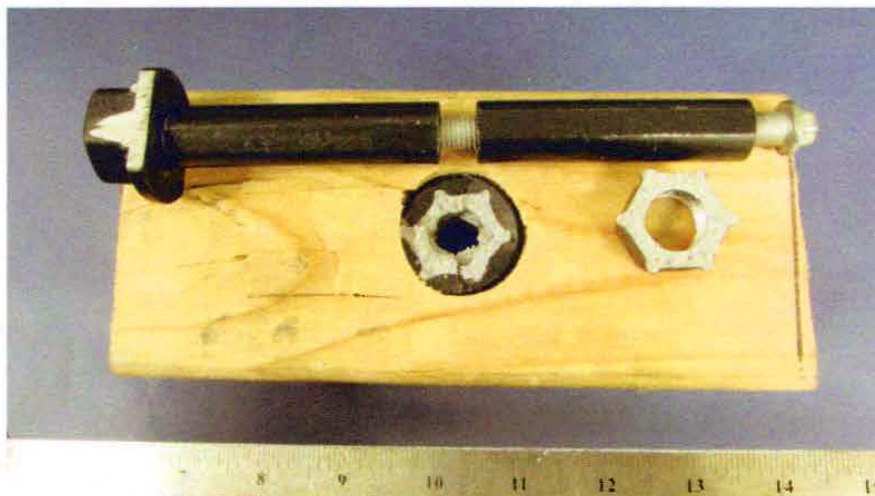
Figure 5: Bolt withdrawal failure mechanism for OWT

Sample ID	Peak Load, lbs	Observations
56650-1	3,402	Hex nut failed @ bottom side of fixture
56650-2	3,472	
56650-3	3,822

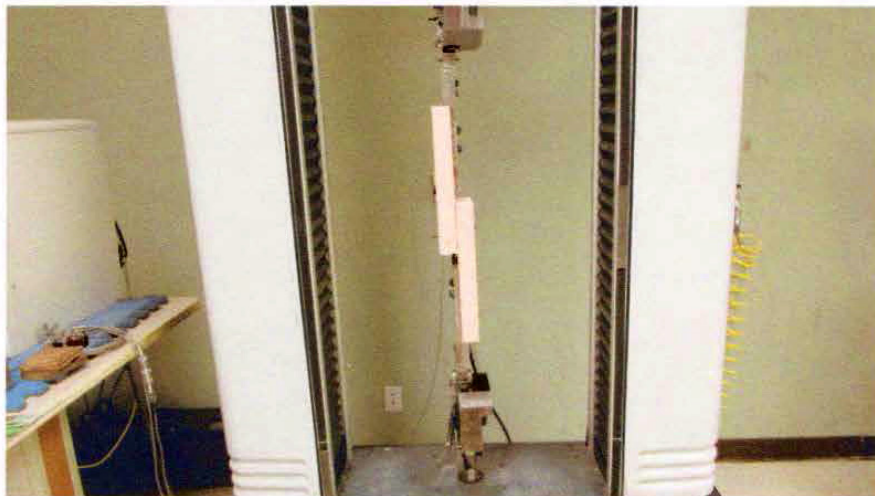
Figure 6: Lateral load test setup for screw

Lateral load testing was performed per ASTM D1761, which resulted in shearing of the wood materials prior to failure of the screws.

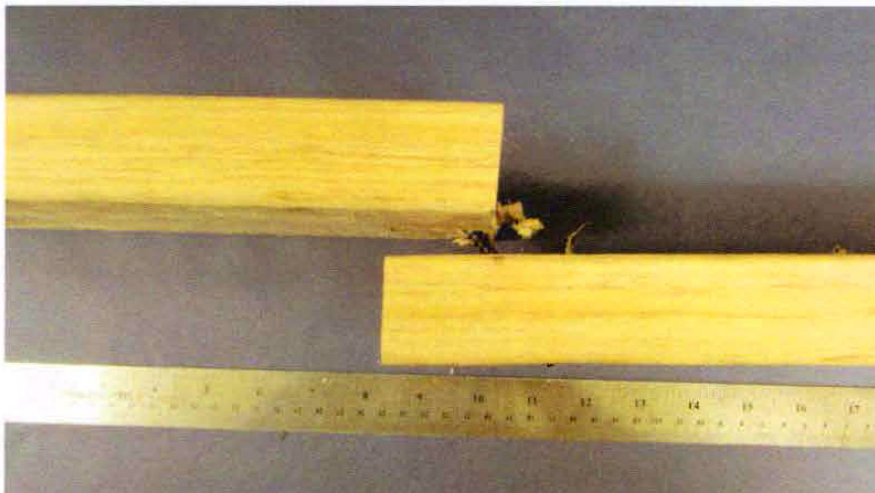
Figure 7: Lateral load test failure mechanism

Sample ID	Peak Load, lbs	Observations
56627-1	1,015	Screw pulled through wood
56627-2	1,222	
56627-3	1,391

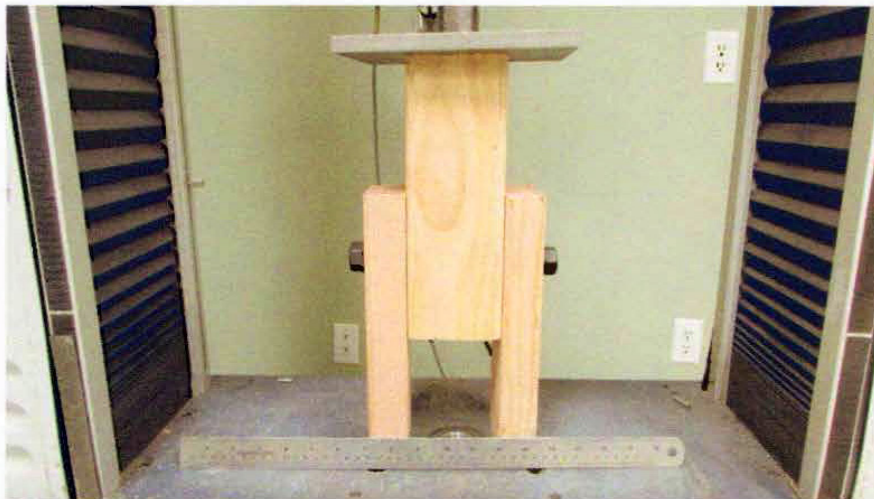
Figure 8: Lateral load test setup

Lateral load testing per ASTM D1761 produced two failure mechanisms. On the lower test values, the wood materials split, while the hex nut failed at the highest peak load.

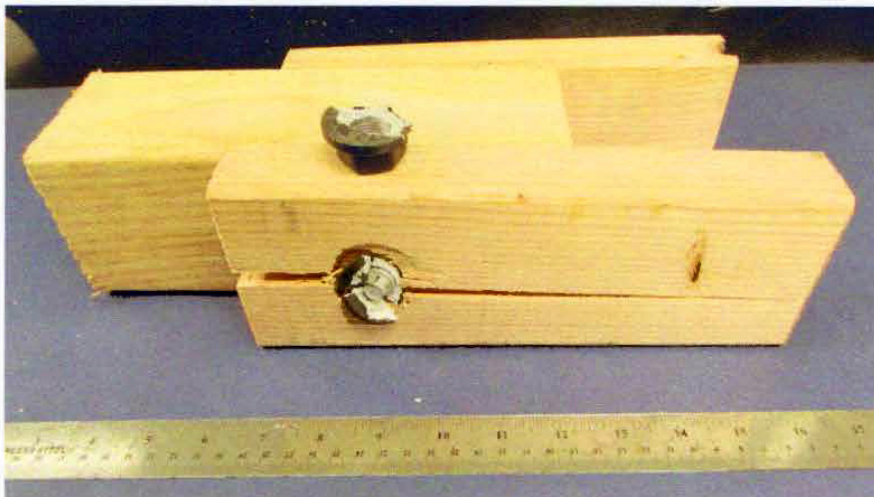
Figure 9: Lateral load failure mechanism

Sample ID	Peak Load, lbs	Observations
56650-1	6,827	Hex nut and wood split failure
56650-2	5,448	Wood split
56650-3	6,202	Wood split

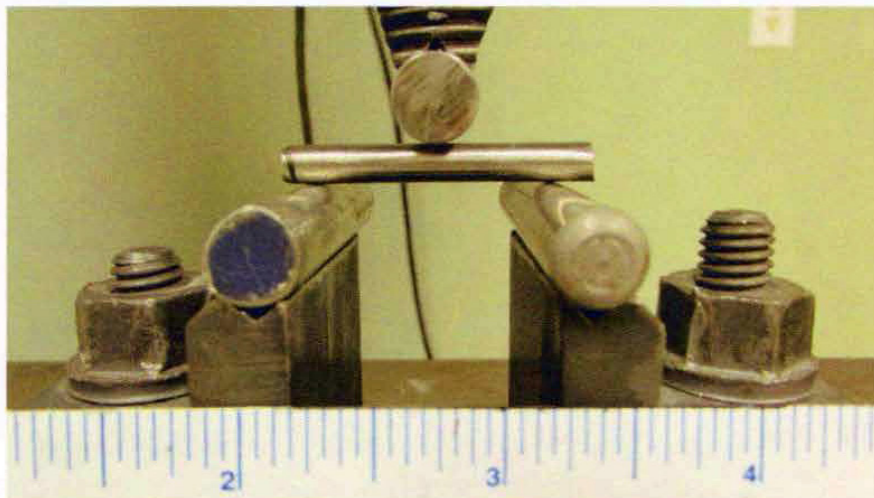
Figure 10: Bend test setup for screw shank

Bend testing was performed on screw shanks per ASTM F1575 (modified).

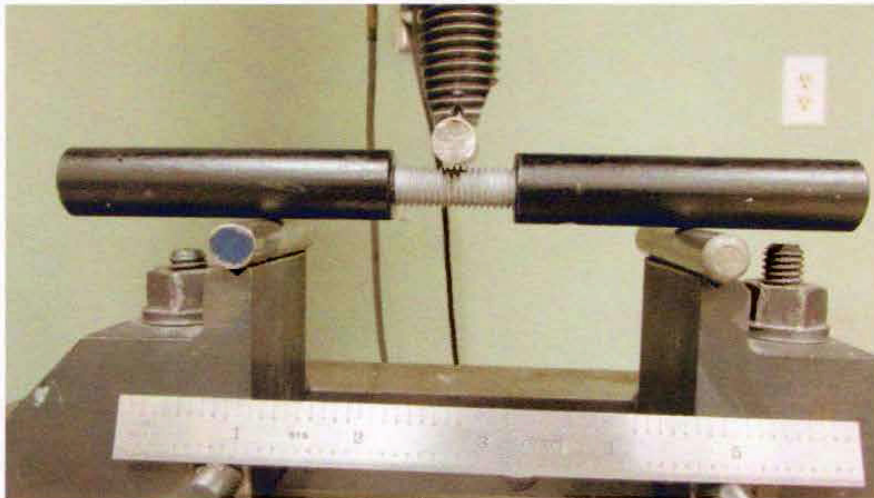
Figure 11: Bend test setup for OWT

Bend testing was performed on OWT bolts per ASTM F1575 (modified).

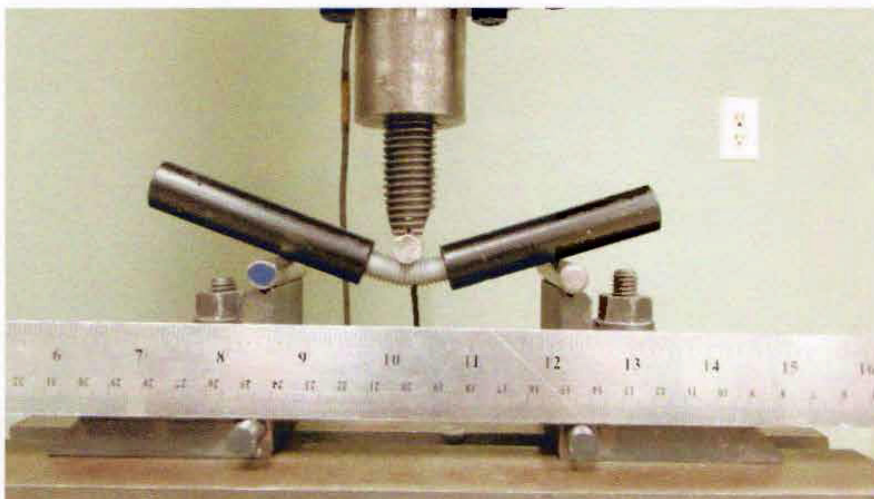
Figure 12: Failure mechanism for bend test of OWT

Bolt Sample ID	Peak Load, lbs	Peak Stress, psi
56650-1	948	10,764
56650-2	934	10,599
56650-3	953	10,812
